RE-70-197

**STRUCTURAL STABILITY OF A CAST Co-Cr-Mo ALLOY  
DURING IMPULSIVE THERMAL-MECHANICAL LOADING**

**TECHNICAL REPORT**

**U. S. ARMY WEAPONS COMMAND**

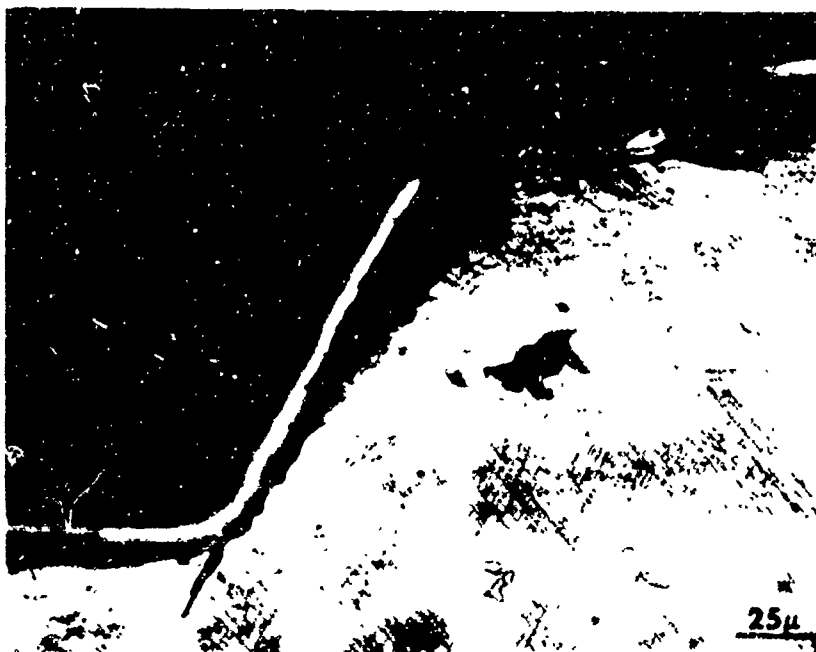
As the firing was continued to 3000 rounds under Schedule A, the slip patterns remained basically unchanged; however, they did become more definite and more dense. Rounding of the land corners was observed (Figure 6) as well as increased crack formation and development. Although cracks have been noted to follow the carbide-matrix boundary, extensive crack propagation through carbides was also observed as typified in Figure 7. These cracks generally followed a direction radial to the bore surface.

FIGURE 6 MICROSTRUCTURE OF THE LAND AREA  
AFTER 3000 ROUNDS

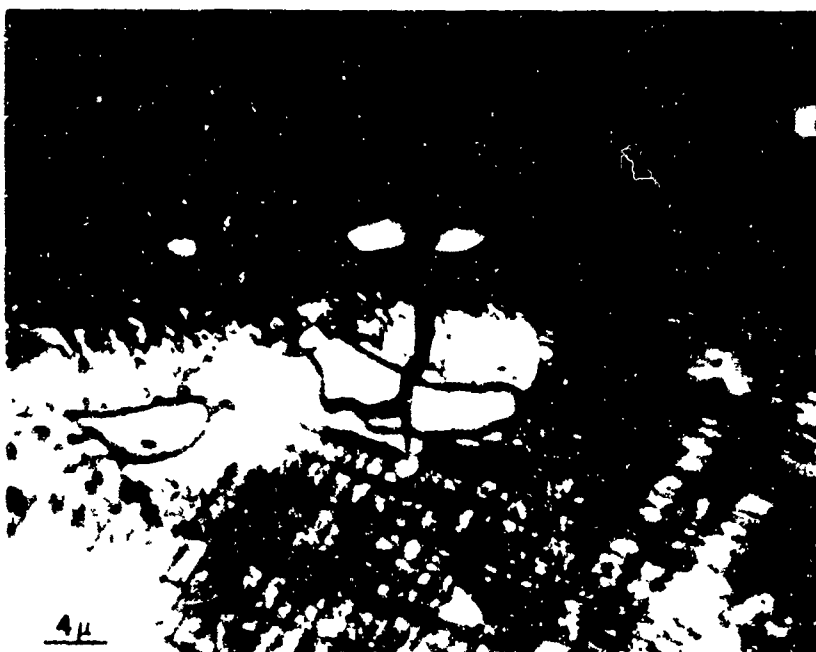
FIGURE 7 PHOTOMICROGRAPH SHOWING CRACK PROPAGATION  
THROUGH CARBIDES AFTER 3000 ROUNDS

Continued firing to 3000 rounds resulted in cracks at the carbide-matrix boundaries and also in cleavage within the carbides. Also, intrusion formation in the matrix proceeded concurrently with the carbide-cracking reaction. Since the as-machined structure shows an intensive amount of slip, deformation in the form of cracks was unlikely to occur early in the firing sequence. Cobalt and its alloys have low stacking-fault energies and, therefore, have a low capacity for cross slip. Thus, actual deformation strains can be accommodated by separation at the carbide-matrix boundaries or within the carbide itself.

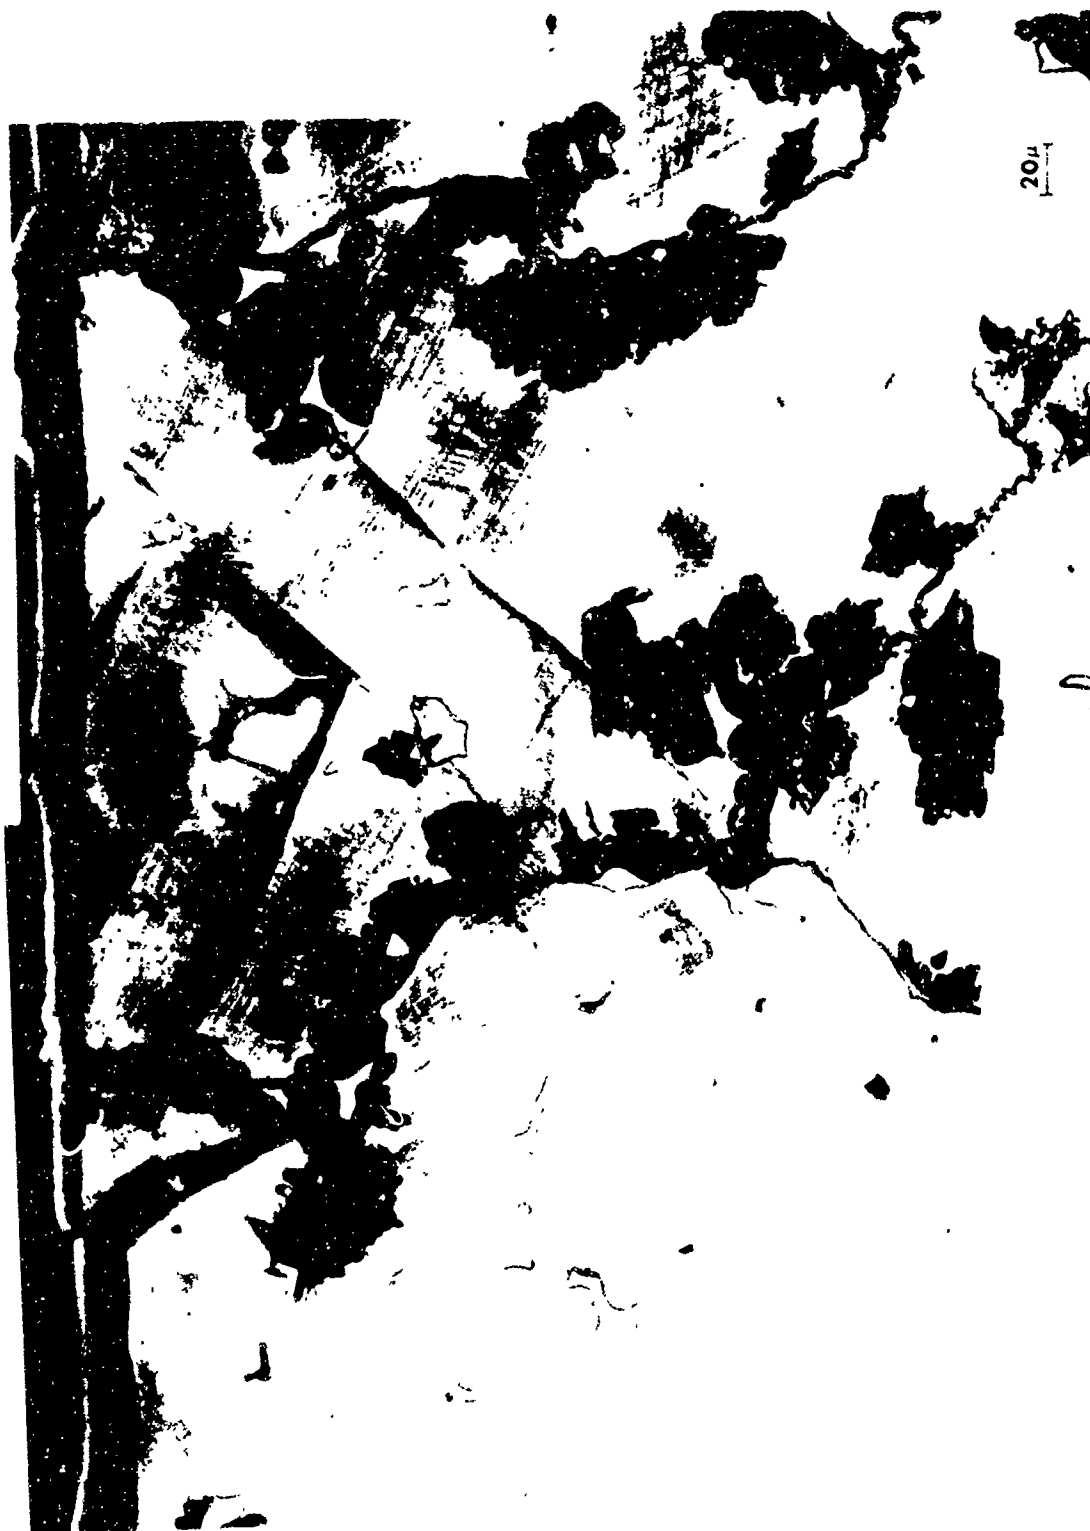
FIGURE 14

CRACK DEVELOPMENT AND INTERSECTION  
AFTER EXTENSIVE FIRING IN 7.62MM INSERT

Prolonged firing schedules on 7.62mm inserts resulted in gross material-loss as a result of the intersection of transgranular cracks as well as of intergranular cracks.

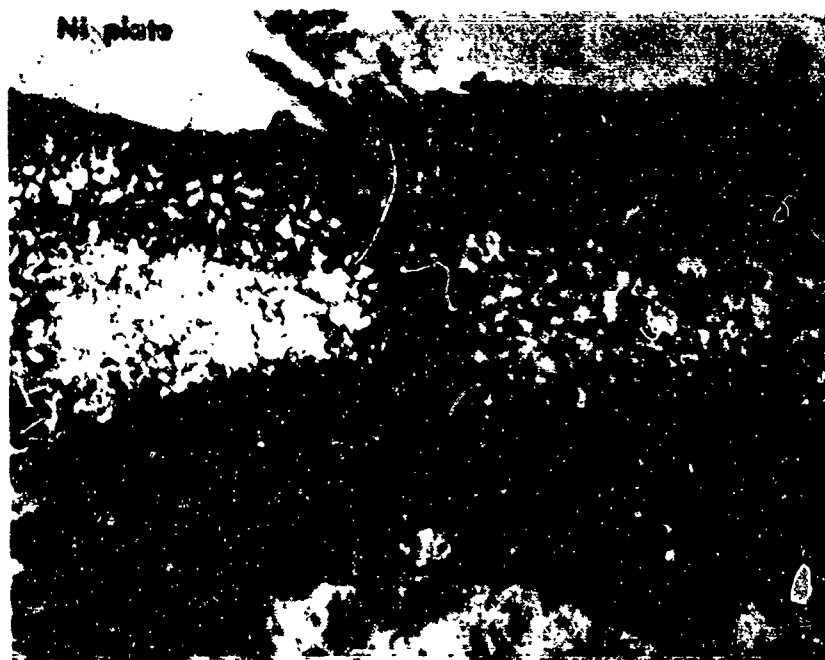
Structural differences after firing were noted for the cast Alloy 21 inserts used in larger caliber weapons. Analyses on the caliber .50 insert were performed. Although a record of the actual firing schedule was unavailable for this insert, evidences of severe firing practice were noted. Occurrence of melting in the extreme surface layers is shown in Figure 15. Just below this area, structures exhibiting recrystallization or the hcp+fcc reversion were observed (Figure 16).

FIGURE 15 SURFACE AREA STRUCTURE OF  
CALIBER .50 INSERT AFTER FIRING

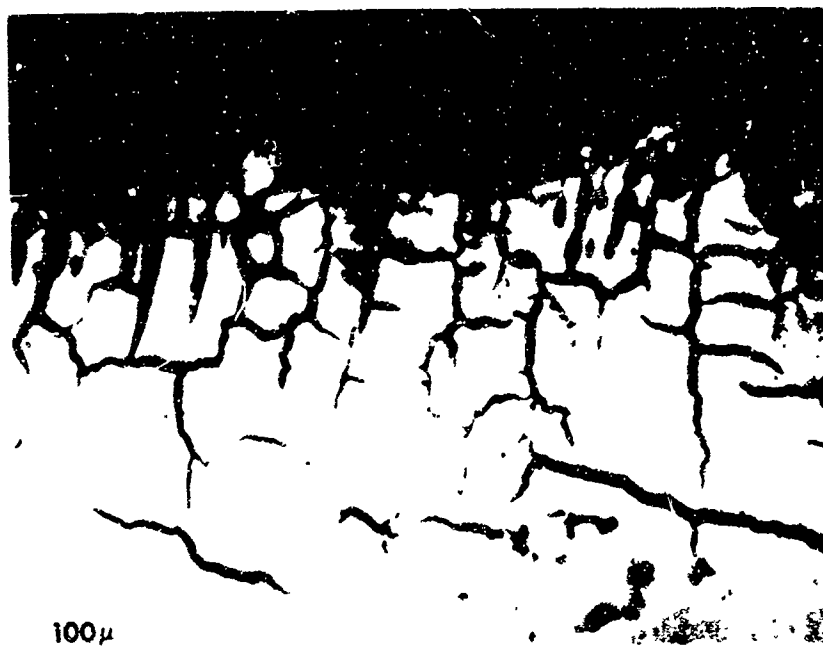
Widespread crack development was noted for the larger caliber, 20mm automatic weapon. The structure after 7170 rounds of fire (Schedule D) is shown in Figure 18. This particular sample was sectioned longitudinally and polished at a low angle to exhibit a larger surface area. Surface layer melting, extensive chemical reaction, and aging were observed for this insert as shown in Figure 19.

FIGURE 18 LOW ANGLE SURFACE PROFILE SECTION  
SHOWING EXTENSIVE CRACK DEVELOPMENT  
IN 20MM INSERT AFTER 7170 ROUNDS

Although cracks generally appeared to grow radially from the bore surface (shown earlier in Figure 18), continued propagation into the interior exhibited orientations approximately 45 degrees to the bore surface as shown in Figure 20. These cracks progressed transgranularly, following principal slip-plane orientations and changed direction slightly at grain boundaries. Evidence of plastic blunting of the crack tip is shown in Figure 20 as well as in Figure 21. Also, cracking through the carbide particles is noted in Figure 21.
